A TECHNICAL SUMMARY OF PERFORMANCE:
LITTORAL SHELF FILTERS AS A
WET POND RETROFIT

North Carolina State University

Stormwater Engineering Group

7/31/2020

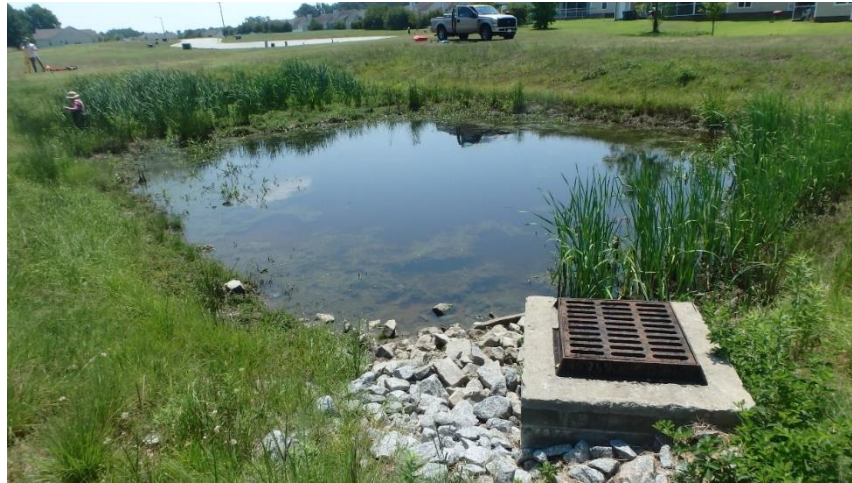
Figure 1. Sapphire wet pond in Rocky Mount, NC.

A 3,895 ft² wet pond receiving runoff from the 7.3-acre Sapphire Road residential area watershed in Rocky Mount, NC, was retrofit with a 408 ft² littoral shelf filter in October 2017 (Figure 1). The filter was installed along the south bank of the wet pond (Figure 2). The filter was installed at permanent pool elevation with an approximately 4-inch high berm separating the filter surface from the permanent pool surface. The filter was lined with an impermeable liner to prevent seepage of water from the banks of the pond and ensure only stormwater above the permanent pool would be routed through the system. Above the impermeable liner, the filter was backfilled with a 6-inch layer of double-washed #57 stone, a 3-inch layer of double-washed

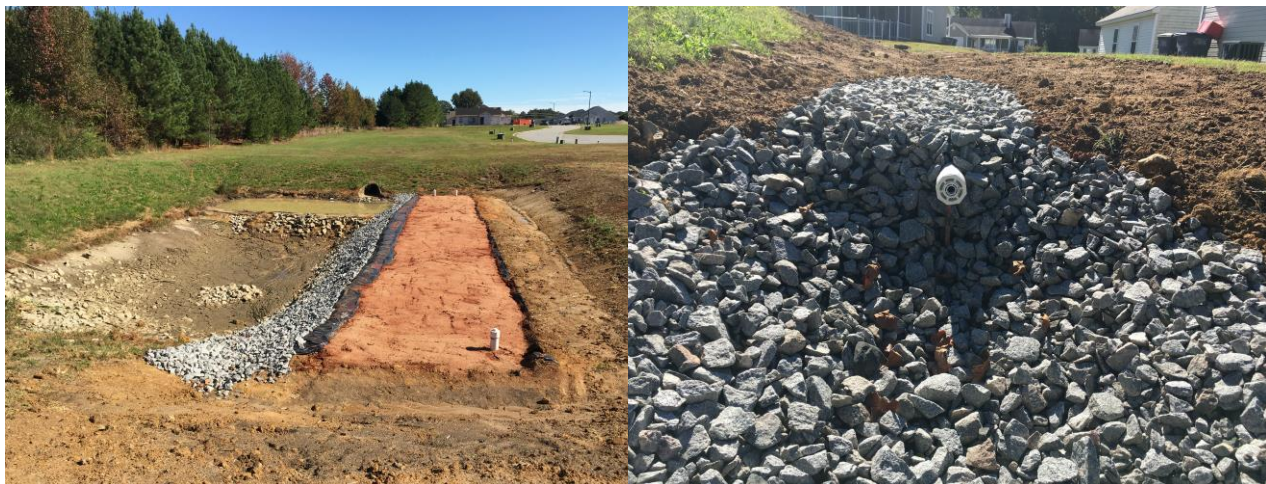
Figure 2. Sapphire littoral shelf filter following construction (left) and underdrain (right).

#87 stone, and 1.5 feet of ViroPhos filter media donated by EnviRemed Environmental Services. The filter was drained through two 4-inch perforated underdrains that were daylighted to a swale outside of the wet pond and fitted to a 1-inch nozzle (Figure 2).

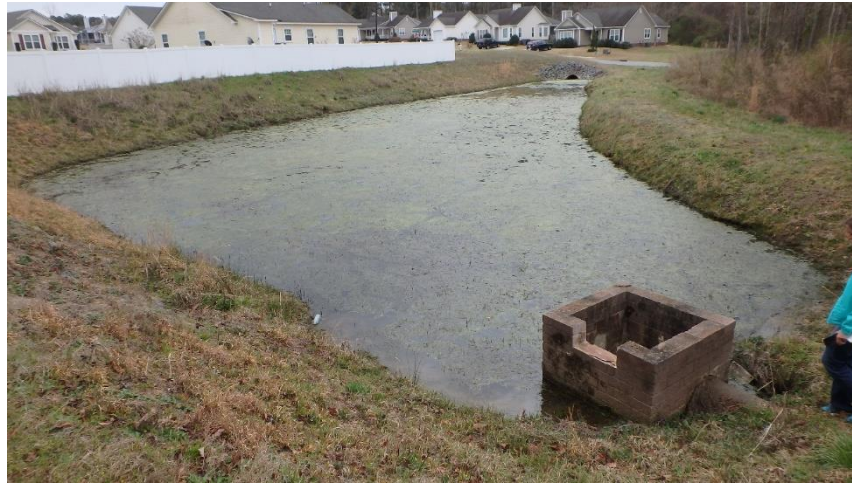
Figure 3. Bridgewood wet pond in Rocky Mount, NC.

A 6,691 ft² wet pond receiving runoff from the 17.1-acre Bridgewood Road residential area watershed in Rocky Mount, NC, was retrofit with a 354 ft² littoral shelf filter in October 2017 (Figure 3 **Figure 1**). The filter was installed along the western bank of the pond at permanent pool elevation with an approximately 4-inch high berm separating the filter surface from the permanent pool surface (Figure 4). As at Sapphire, the filter was lined with an impermeable liner to prevent seepage of water from the banks of the pond and ensure only stormwater above the permanent pool would be routed through the system. Above the impermeable liner, the filter was backfilled with a 6-inch layer of double-washed #57 stone, a 3-inch layer of double-washed

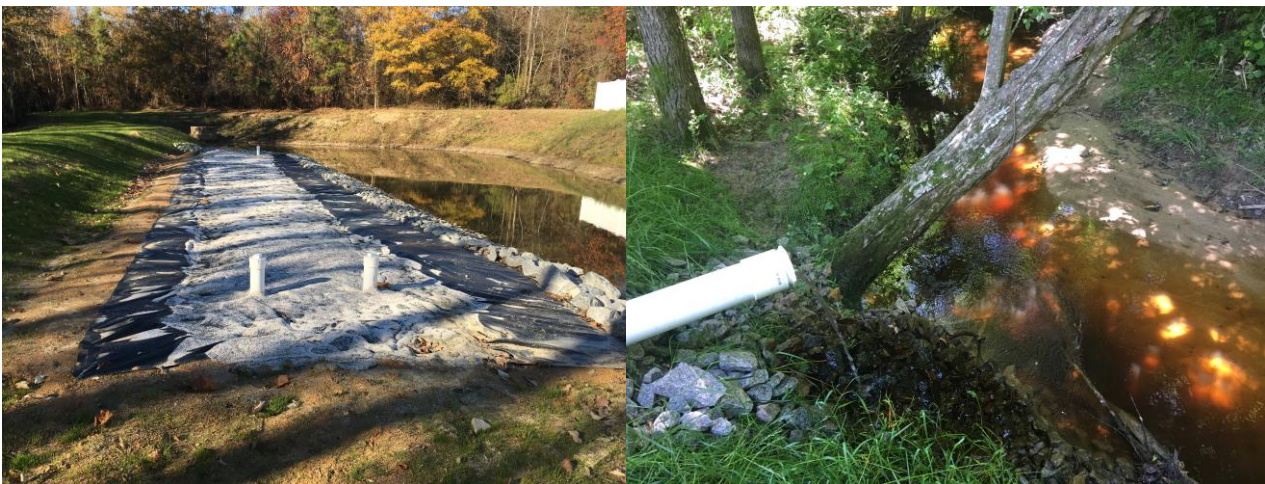
Figure 4. Bridgewood littoral shelf filter following construction (left) and underdrain (right).

#87 stone, and 1.5 feet of Bold & Gold® filter media donated by Environmental Conservation Solutions. The filter was drained through two 4-inch perforated underdrains that were daylighted to a stream adjacent to the wet pond and fitted to a 1-inch nozzle.

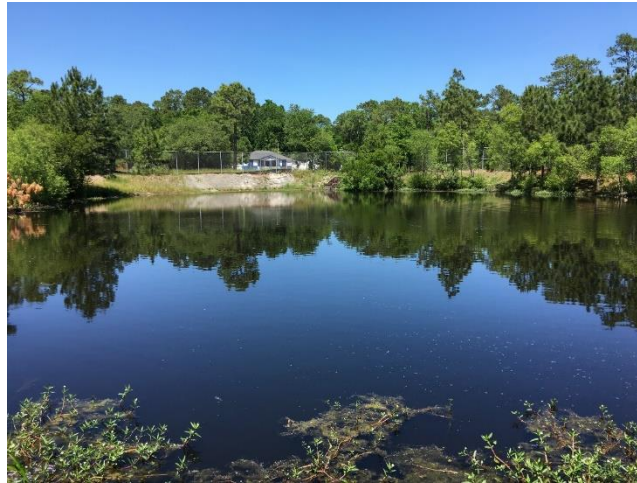
Figure 5. Wilmington Operations Center wet pond.

Lastly, a 1-acre wet pond in Wilmington, NC, receiving runoff from the 30-acre municipal operations center was retrofit to include a littoral shelf filter (Figure 5). The 240 ft² littoral shelf filter was constructed in August 2016 adjacent to the pond's existing outlet structure and was installed at permanent pool elevation with an approximately 4-inch high berm separating the filter surface from the permanent pool surface (Figure 6). The filter was lined with an impermeable liner to prevent seepage of water from the banks of the pond and ensure only stormwater above the permanent pool would be routed through the system. Above the impermeable liner, the filter was backfilled with a 6-inch layer of compacted double-washed #57 stone, an uncompacted 6-inch

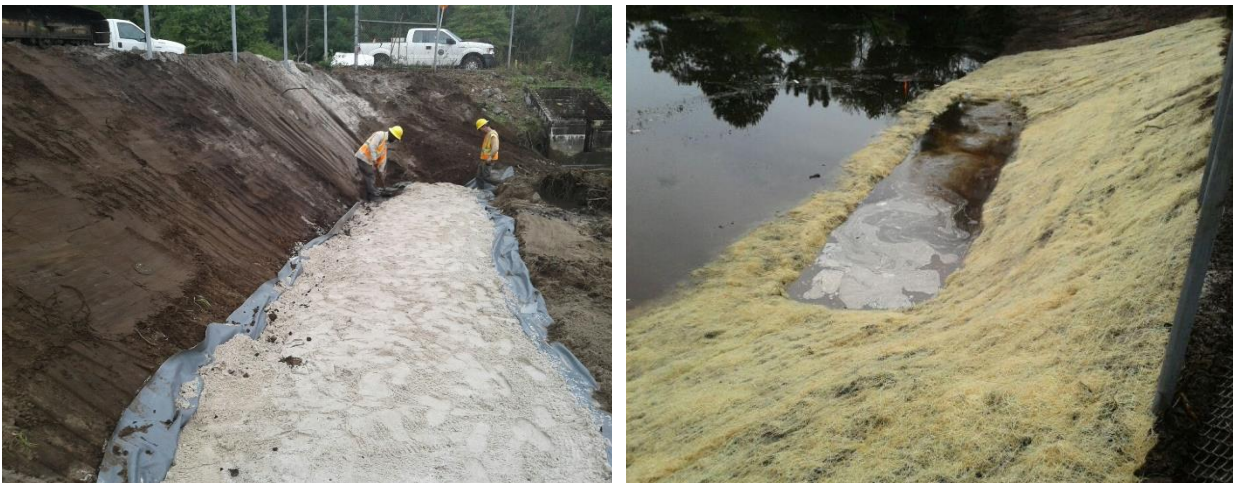
Figure 6. Littoral shelf filter during construction (left) and following a rain event (right).

layer of double-washed #57 stone, a 3-inch layer of double-washed #87 stone, and 1.5 feet of Bold & Gold® filter media donated by Environmental Conservation Solutions. The filter was drained through two 4-inch perforated underdrains that were daylighted within the existing pond’s outlet structure and fitted to a 1-inch nozzle.

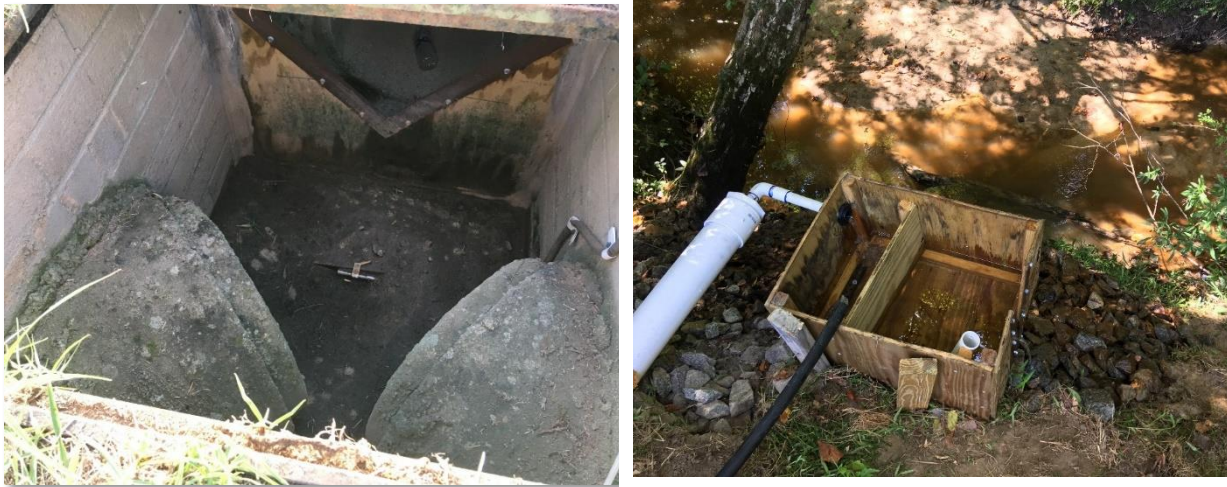
Figure 7. Monitoring equipment installed at the inlet of Sapphire pond (left) and filter underdrain at Bridgewood (right).

Following retrofit, Onset HOBO U20 water level loggers were installed to monitor water levels within the shelf filters and Teledyne ISCO monitoring equipment was installed to monitor hydrology and water quality associated with each retrofit. At Bridgewood and Sapphire, sharp crested v-notch weirs were installed within the catch basin inlets and outlet structures of each pond and within a weir box surrounding each daylighted underdrain. ISCO bubbler modules

measured water levels over each weir and flow rates were calculated using stage-discharge relationships. Flow-weighted volumetric water quality samples were collected at each monitoring location (pond influent, pond effluent, and filter effluent) using ISCO programmable automated samplers and were delivered for laboratory analysis within 24 hours of rainfall cessation.

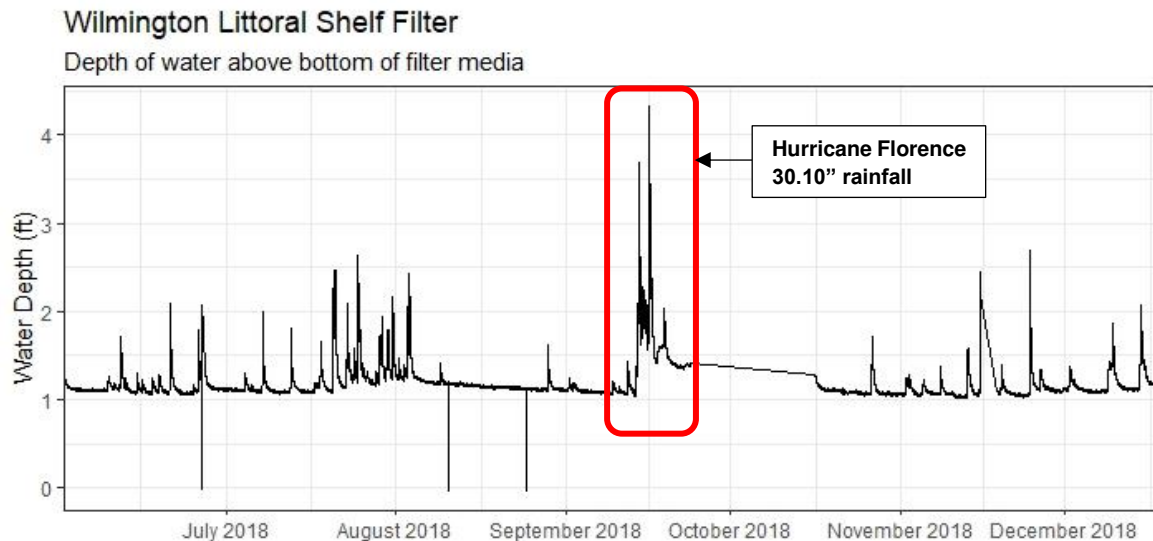
Figure 8. Water levels within the filter from June - December 2018.

At the Wilmington Operations Center pond, hydrologic monitoring using the AVM and water level loggers was intended to allow calculation of flows through the filter underdrain and over the pond outlet structure's weir. While the filter included an impermeable liner to prevent seepage from the pond's banks and allow calculation of inter-event flows, it became apparent shortly after construction that the impermeable liner was compromised during installation. Water remained in the filter regardless of the presence of a rain event with a median depth of 1.1 ft

throughout the monitoring period (Fig. 3). As such, constant flows through the underdrain confounded efforts to calculate event based pathogen loads.

While the Wilmington filter remained active even during dry periods, the filter still received stormwater runoff during storm events as evidenced by the spikes in internal water levels during rain events seen in Figure 3. That grab samples were only collected during rain events still allows pathogen removal comparisons.

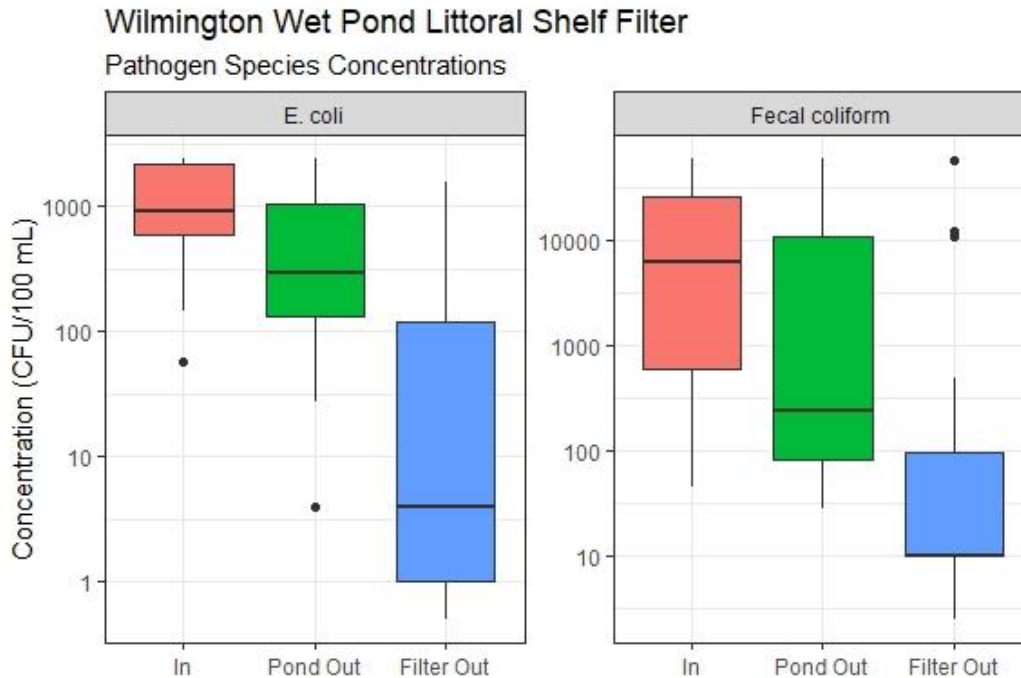
Figure 10. Pathogen species concentrations.

E. coli ER was 73% for the pond while the filter improved the performance of the pond by 95%. While the pond alone reduced E. coli by 73%, reductions were not statistically significant. Three of nine sampled events resulted in an export of E. coli from the pond, likely due to the presence of waterfowl inhabiting the pond (Table 1). However, E. coli concentrations were significantly reduced by the filter when compared to both runoff into the pond and pond effluent (Fig. 4).

Similarly, the filter significantly reduced FC concentrations when compared to pond influent and effluent while the pond was not able to significantly reduce FC from stormwater runoff. FC removal in the pond was highly varied with five of nine sampled events representing an export of FC (Table 1). Again, increases in FC within the pond are likely due to the presence of waterfowl inhabiting the pond. FC ER was 81% for the pond while the filter improved the pond’s performance by 92%.

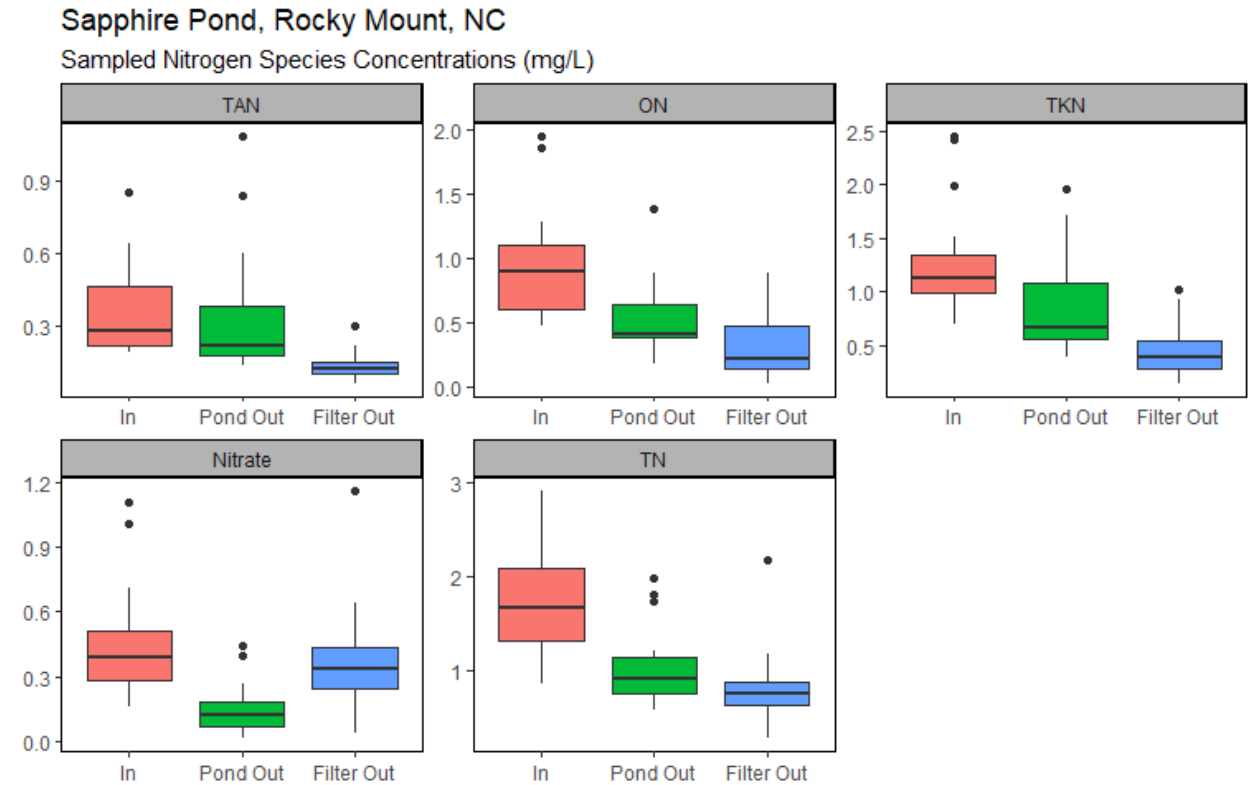
Figure 11. Nitrogen species concentrations (mg/L) at each monitoring location at Sapphire wet pond in Rocky Mount, NC.

At the Sapphire Pond, influent TN concentrations ranged from 0.86 to 2.92 mg/L, pond effluent TN concentrations ranged from 0.58 to 1.99 mg/L, and filter effluent TN concentrations ranged from 0.28 to 2.18 mg/L. Median TN concentrations for pond influent, pond effluent, and filter effluent were 1.67, 0.93, and 0.77 mg/L, respectively (Table 2). The Sapphire filter was able to reduce influent TN concentrations by a median of 49%. When compared to pond effluent, filter effluent TN concentrations were reduced for 78% of events. The pond was able to significantly

reduce TN concentrations with a median ER_{pond} of 38% while the filter provided an additional significant reduction with a median ER_{filter} of 11%.

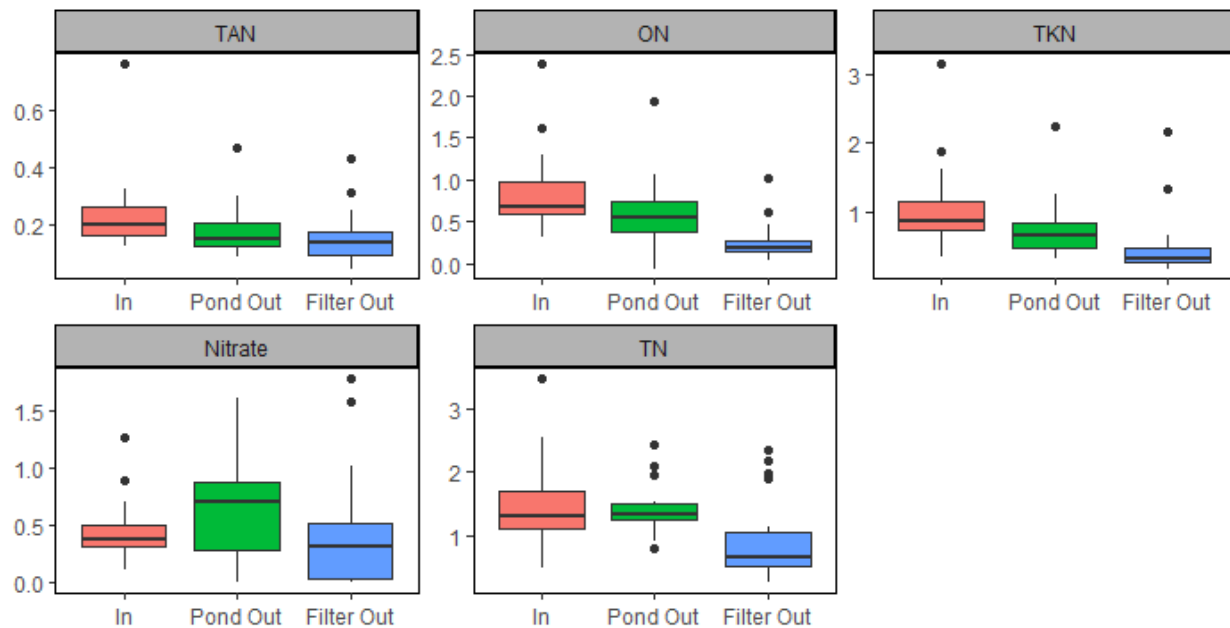
Bridgewood Pond, Rocky Mount, NC
 Sampled Nitrogen Species Concentrations (mg/L)

Figure 12. Nitrogen species concentrations (mg/L) at each monitoring location at Sapphire wet pond in Rocky Mount, NC.

At Bridgewood, TN concentrations were more varied, with influent concentrations ranging from 0.47 to 3.50 mg/L. Overall, median TN concentrations were 1.29, 1.34, and 0.65 mg/L for pond influent, pond effluent, and filter effluent, respectively (Table 2). The pond itself did not remove nitrogen (median TN removal rate of 0%), demonstrating why retrofits are needed. The retrofit filter significantly reduced TN when compared to the pond itself with a median removal rate of 54%.

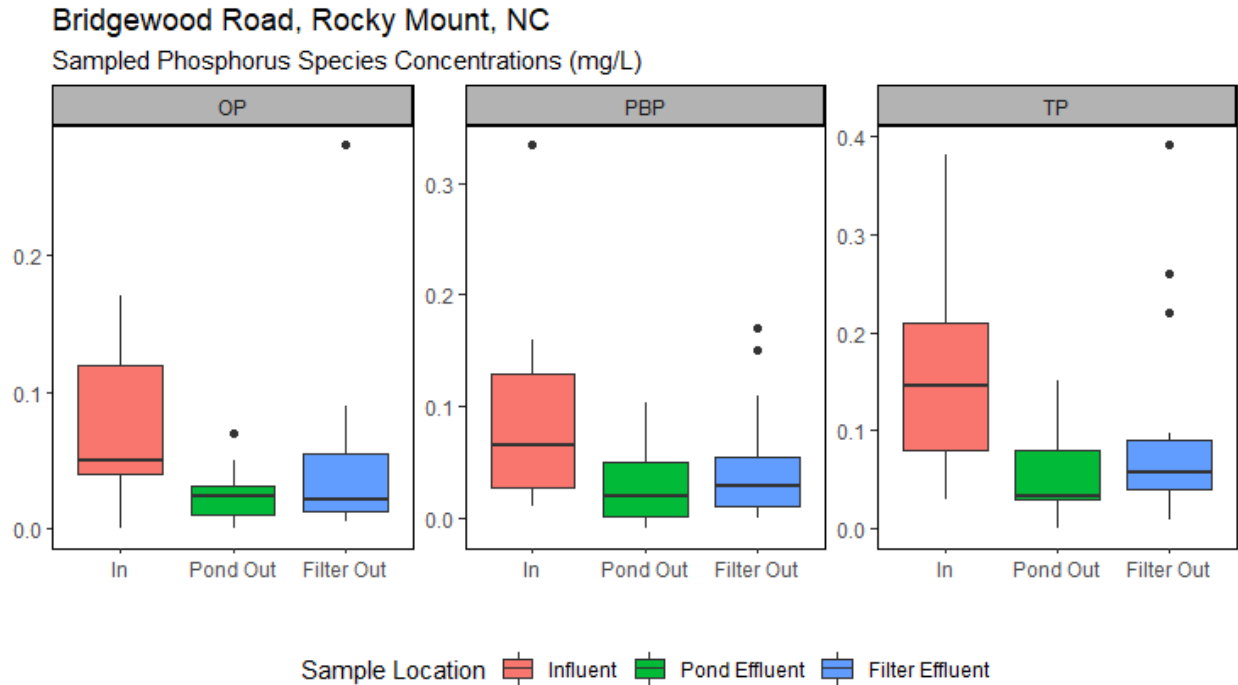
Figure 14. Phosphorus species concentrations (mg/L) at each monitoring location at Bridgewood wet pond in Rocky Mount, NC.

At Bridgewood, the filter significantly increased TP concentrations when compared to the filter, with a median removal rate of -14%. However, the pond was very efficient at removing TP, with a median TP reduction of 65%. While a significant increase when compared to pond effluent (median TP concentration = 0.03 mg/L), filter effluent TP concentrations were still low (median TP concentration = 0.06 mg/L) and significantly less than influent TP concentrations (median = 0.15 mg/L).

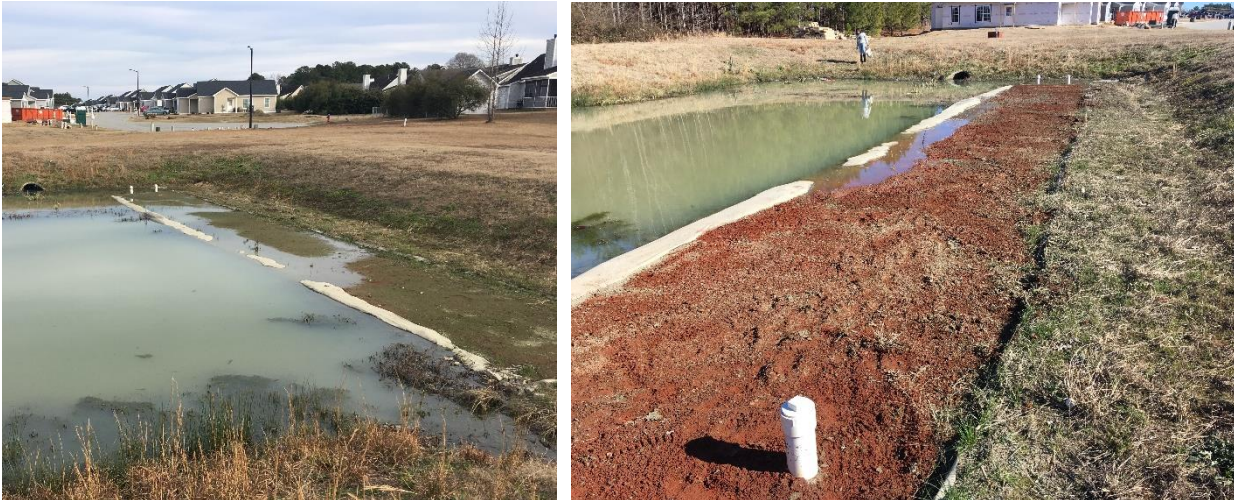
Figure 16. Biological blinding of the shelf filter observed at the Sapphire pond (left) remedied by raking of the filter surface (right).

Maintaining adequate infiltration of the filter media is essential to littoral shelf filter functionality and performance. While the Wilmington filter presented constant discharge, volunteer vegetation rooted into the filter media and sediment from the pond accumulated on the filter surface. In Rocky Mount, sediment from the developing watershed at the Sapphire pond resulted in sediment accumulation on the littoral shelf filter surface leading to areas of clogging (Figure 16).

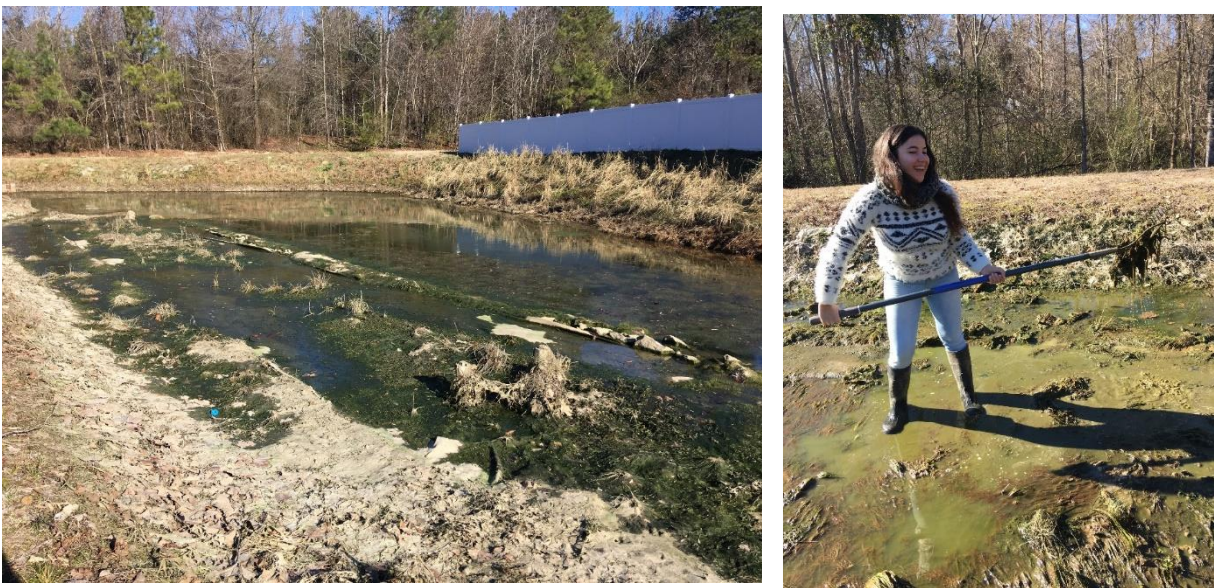
Figure 17. Clogging of the Bridgewood filter with biological material (left) and restoring infiltration by removing and raking the filter (right).

As aforementioned, the Bridgewood pond was highly active with biological material and became regularly clogged with moss and algae (Figure 17). However, clogging of the surface layer was easily remedied by raking accumulated material (both biological and sediment). Following removal of material and raking of the surface layer of media, infiltration of filters was restored. While an easy fix, regular maintenance of the filter surface area (particularly during the growing season) needs to be planned and budgeted for successful future implementation.

To prevent issues with clogging in future implementations, a maintenance schedule of semi-annual media surface raking is recommended. For wet ponds similar to Bridgewood, where biological activity is particularly present, more frequent maintenance will be required. For these ponds, pre-installation maintenance to treat the cause of moss and algal growth is recommended to reduce the post-installation maintenance burden and prolong the life of the filter media in the littoral shelf filter.
