CUSTOMER CASE STUDY

Mt. Jackson Solar

Mount Jackson, Virginia

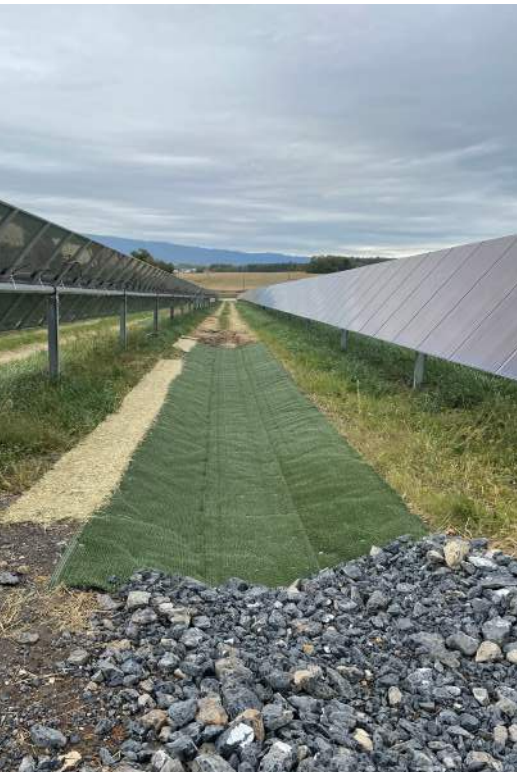
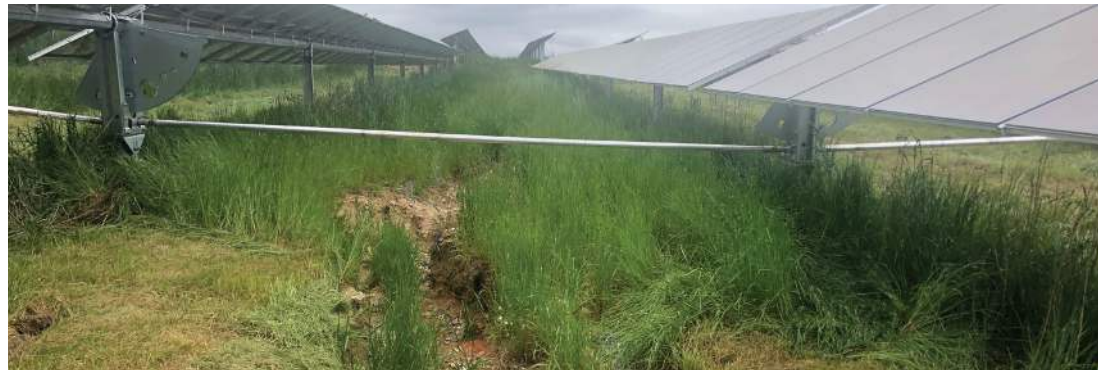
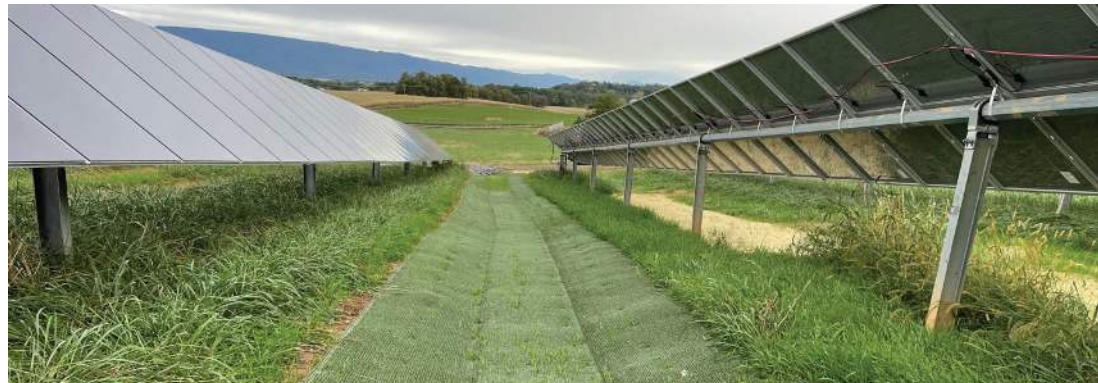
Unsuccessful stabilization attempts made in the past led to severe erosion in critical drainage channels on a newly constructed solar farm in Mt. Jackson, VA. The absence of vegetation allowed the channels to erode very quickly. They needed to be repaired and protected as soon as possible to prevent further damage.

Erosion on the solar farm had disturbed the natural slope of the channel. To start the project, the channels were regraded with compact construction equipment. When the grade of the channel had been restored, grass seed was added to the dirt to promote vegetation growth. After seeding, the rolls of ShearForce were carefully installed along the channel and then pinned. Anchor trenches were backfilled, and ShearForce was installed.
