REPLACEMENT OF BOWING TIMBER WALL

MECHANICSVILLE, VA

INITIAL CONCERN

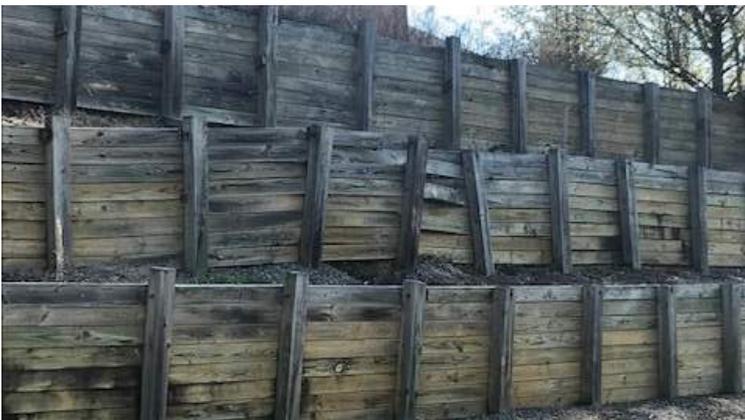
Prior to installation—bowing wall

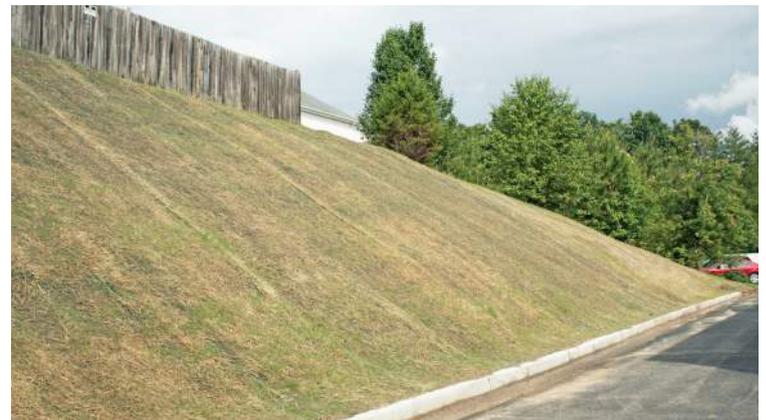
Post-installation with 3 weeks of growth (additional vegetative growth to follow)

The Armormax installation turned out wonderfully, with the vegetation quickly beginning to grow through the mats. A final installation picture showing 3 weeks of growth can be seen above. The client and surrounding tenants are thrilled with the result and are excited to see the final product when the vegetation has more opportunity to grow without the summer heat.

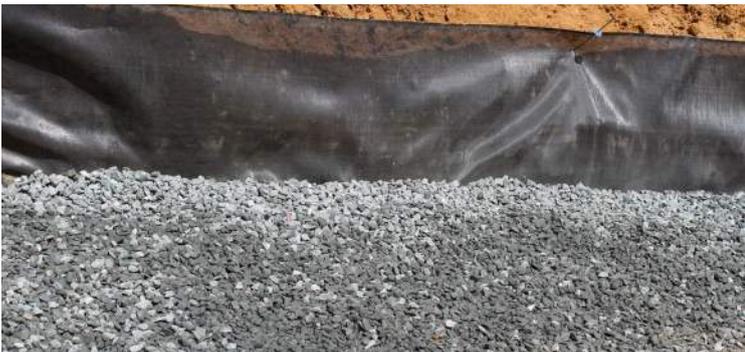
Installation of trench drain using geosynthetic fabric to protect from seepage.

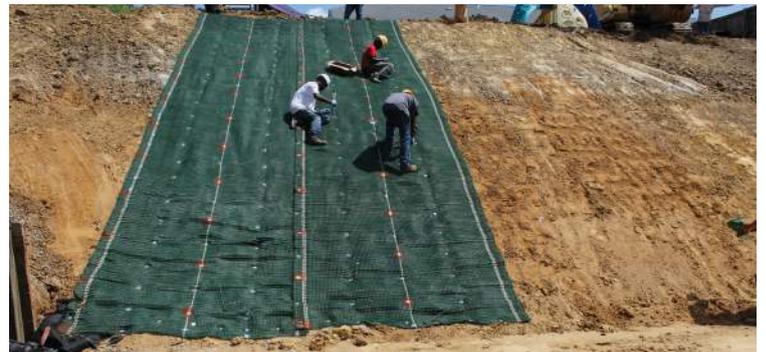
Beginning of Armormax install with Pyramat rolled down the hill and washer pins installed.

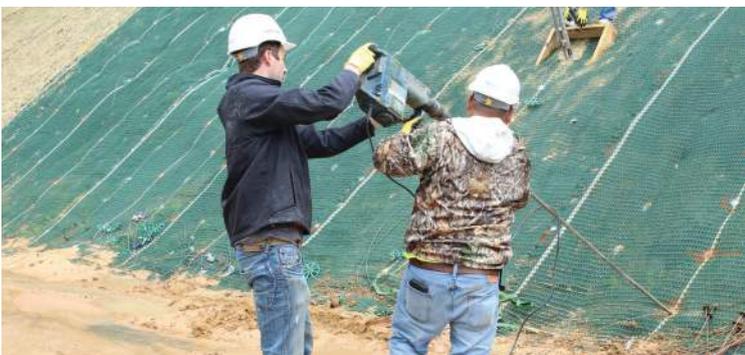
Engineered Earth Anchors installation using a power driver.

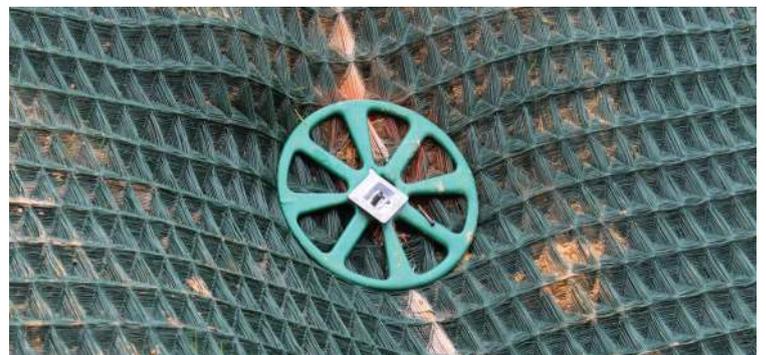
Complete Engineered Earth Anchors installation, with anchor flush against Pyramat.

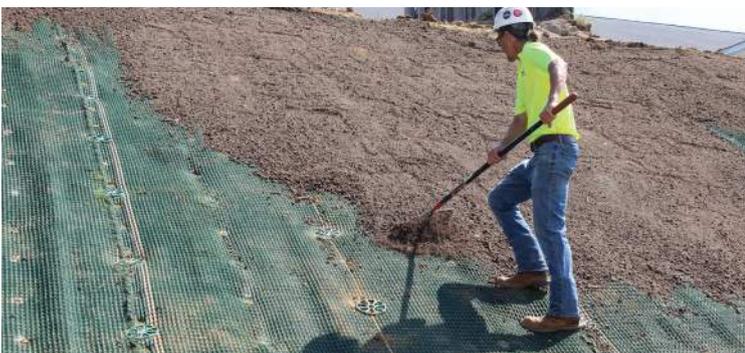
To promote vegetation, seed was placed beneath Armormax, beneath evenly spread soil coating and above soil coating.

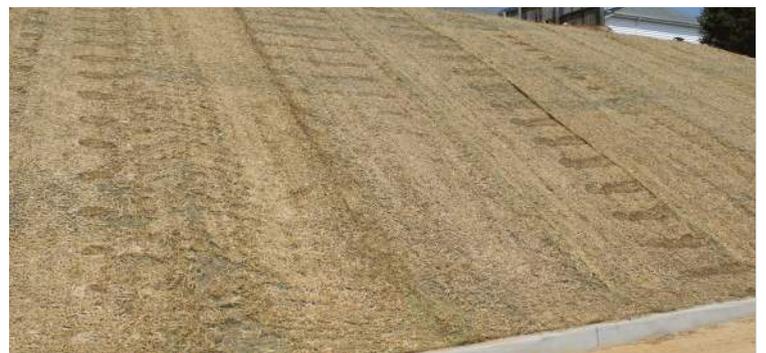
To protect the installation and new vegetation, a straw erosion control mat was installed.
