Technical Note

***FULL-SCALE WAVE OVERTOPPING TESTING OF
HYDROTURF® ADVANCED REVETMENT TECHNOLOGY
FOR LEVEE LANDWARD SIDE SLOPE PROTECTION***

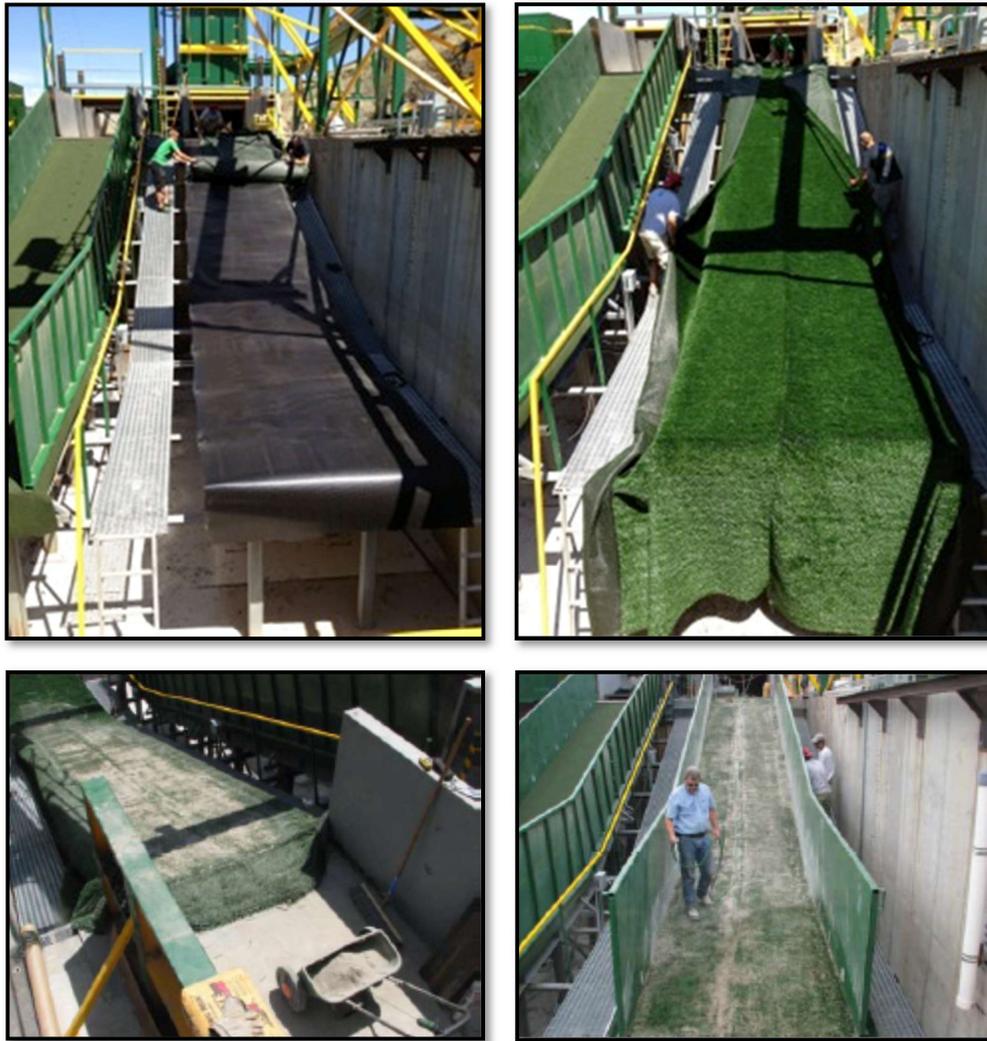
Figure 3. HydroTurf® System Installation

HydroTurf[®] was installed on the compacted soil in the prepared trays. HydroTurf installation began with placing a continuous sheet of the structured geomembrane with the “spike” side down. The geomembrane serves as the underlayer of the system. The engineered synthetic turf was then placed on the geomembrane. A primary purpose of the testing was evaluation of the sewn seam

strength between adjacent pieces of synthetic turf component. Two sections of the synthetic turf were sewn together using a machine similar to that used for field installations. The sewn piece was installed such that the seam direction was parallel to the slope (i.e. in the same direction as flow) along the centerline of the trays. Following turf installation, an approximately ¾ inch thick layer of dry HydroBinder® infill was brushed into the synthetic turf fibers. The dry mixture was placed using a drop spreader and broomed against the grain of the turf to pull the fibers up through the infill. The HydroBinder mix was then hydrated. Installation photos are presented in Figure 3.

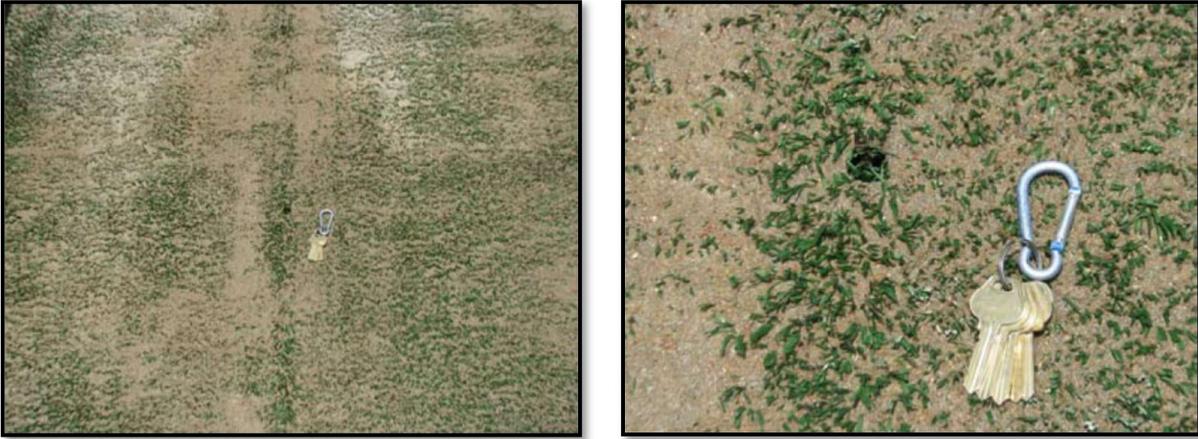
Figure 5. Intentional Damage Simulating a Bullet Hole through HydroTurf®

- Phase 3: Phase 3 was bullet hole damage simulated by driving #4 rebar through the HydroTurf® system into the underlying subgrade. The resulting hole measured approximately 1 inch in diameter and penetrated the turf, infill and geomembrane. The hole is presented in Figure 5.

- **Phase 3. Pulverized HydroBinder Infill and Simulated Bullet Hole.** An additional hour of testing at the maximum facility capacity with pulverized infill and a simulated bullet hole in the HydroTurf resulted in no observed erosion of the silty sand beneath the damaged HydroTurf. The intentional hole did not expand or result in localized erosion. Wave overtopping conditions and highly erodible subgrade condition after Phase 3 are presented in Table 1

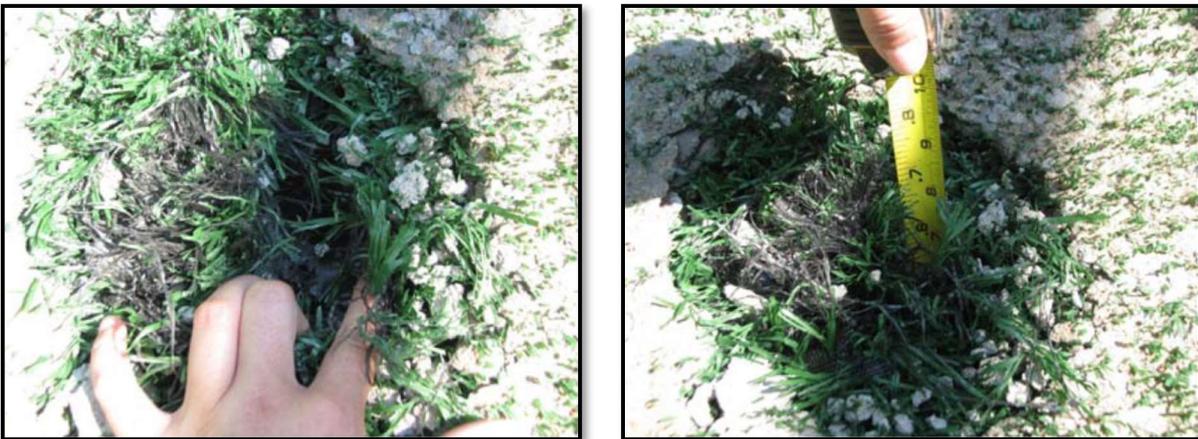
Figure 6. Intentional Damage Simulating a Large Hole through HydroTurf®

- Phase 4: In Phase 4, a pick axe was used to expand the simulated bullet hole creating a larger hole. The larger hole measured approximately 4 inches in diameter and 7-inches deep. The intentional pick axe damage is presented in Figure 6.

- **Phase 4. Pulverized HydroBinder® Infill and Large Hole.** An additional hour of testing at the maximum facility capacity resulted in minimal erosion of the silty sand localized around and downstream of the large hole. No head-cutting was observed at the location of the hole. Wave overtopping conditions and highly erodible subgrade condition after Phase 4 are presented in Table 1.

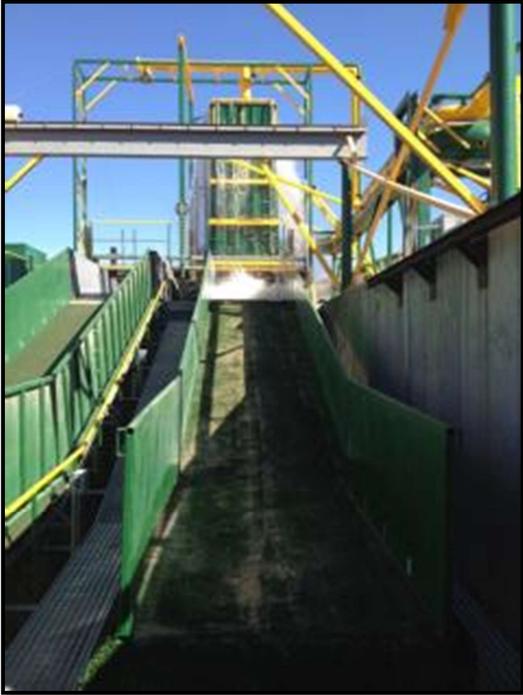
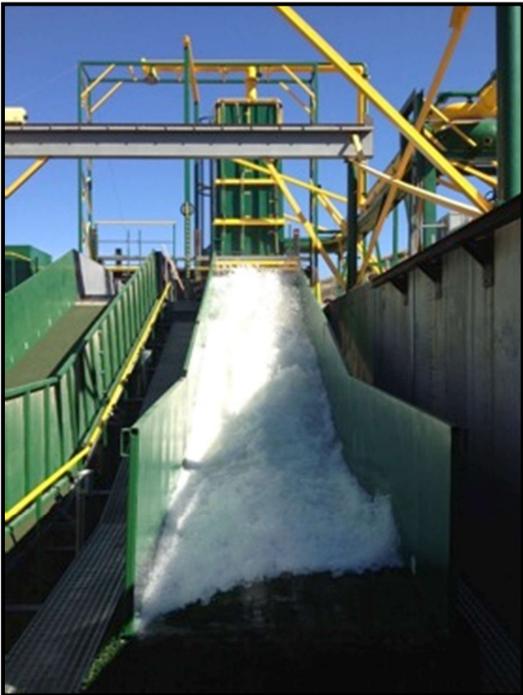
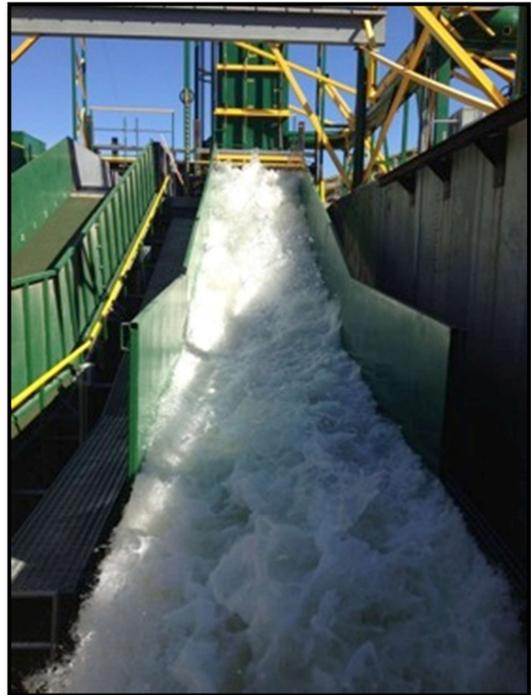
Figure 7. HydroTurf® Wave Overtopping Testing at CSU

The average wave overtopping rate (4 cfs/ft) and volume distribution represented a generic 500-year hurricane (0.2 percent annual exceedance probability) in New Orleans, LA. These wave volumes are the most energetic wave overtopping conditions that can be produced in any existing wave overtopping experimental facility. Testing continued for a total of 13 hours. The largest wave volumes simulated were approximately 1,000 cubic feet (165 ft³/ft) and HydroTurf® was overtopped with over 993,000 ft³ (165,600 ft³/ft) of cumulative volume during the test program. Photos of testing in progress are presented in Figure 7.
